Manhole Inspection Summary

Manhole # S41KK_011MH

Location Address: **1833 SPRING ST**

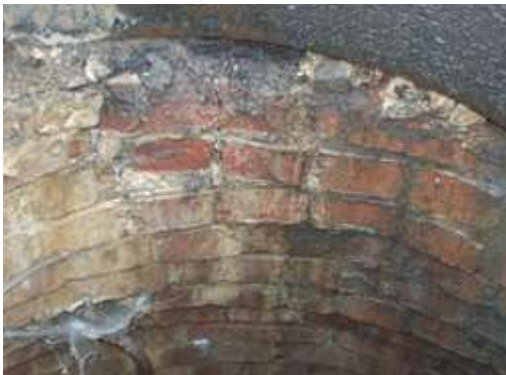
Defect 1

Condition: ☐ Sound ☒ **Cracked** ☐ Root Intrusion ☐ Loose Brick ☒ **Deteriorated**

Cracked and deteriorated chimney

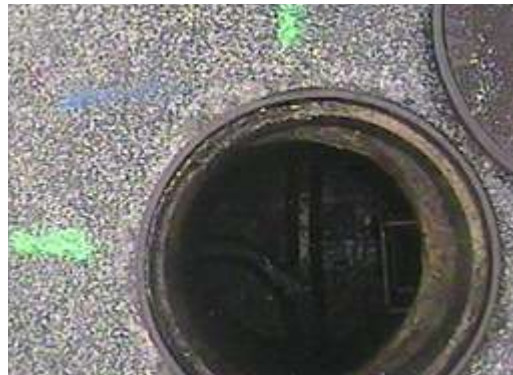
Defect 2

Offset: **4** (in.)

frame offset

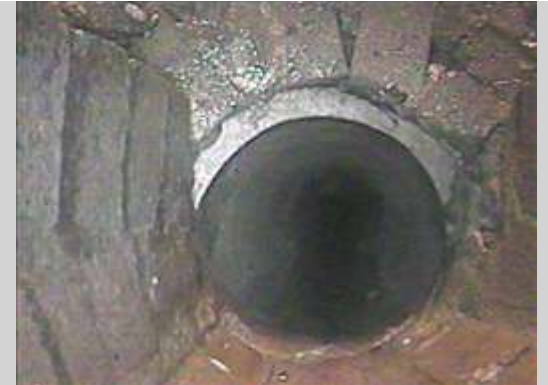
12 O'Clock Outflow

8 in. Circular Gravity Sewer
Pipe Out @ 12 O'Clock

Pipe Height: (in.) Direct
Pipe Material: **Clay** ☐ Pipe Lined
Invert Depth: **8.54** (ft.) Flow Characteristics: **Slow**
Deposits: ☒ None ☐ Mud ☐ Sludge ☐ Debris ☐ Grease
Silt Depth: (in.) Deposits Extent:
Infiltration: **None** Pipe Seal Cond: **Sound**

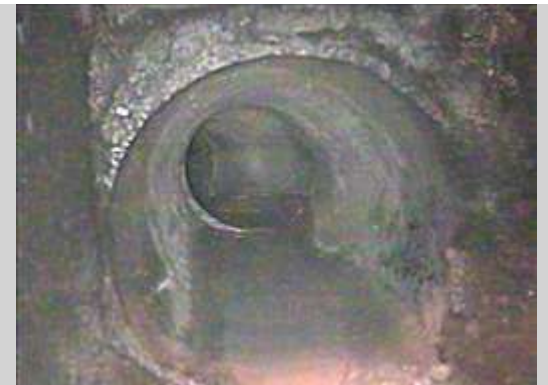
3 O'Clock Inflow

6 in. Circular Gravity Sewer
Pipe In @ 3 O'Clock

Pipe Height: (in.) Direct
Pipe Material: **Clay** ☐ Pipe Lined
Invert Depth: **8.43** (ft.) Flow Characteristics: **Slow**
Deposits: ☒ None ☐ Mud ☐ Sludge ☐ Debris ☐ Grease
Silt Depth: (in.) Deposits Extent:
Infiltration: **None** Pipe Seal Cond: **Sound**

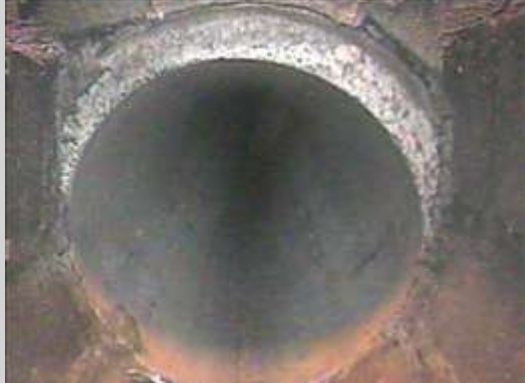
6 O'Clock Inflow

8 in. Circular Gravity Sewer
Pipe In @ 6 O'Clock

Infiltration: **None**

Pipe Seal Cond: **Sound**
